DEVELOPMENT OF A COMPUTERIZED DATA BASE TO MONITOR  
WHEELED VEHICLE CORROSION

OCTOBER 1989

Alfonso L. Baldi  
Edwin A. Crombie  
David P. Dillard  
Alloy Surfaces Company  
100 Locke Road  
Wilmington, Delaware 19809

I. C. Handsy  
U.S. Army Tank-Automotive Command  
ATTN: AMSTA-RSM  
Warren, MI 49397-5000

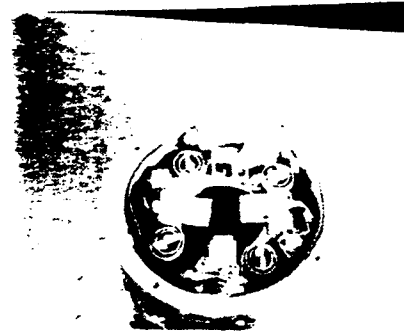
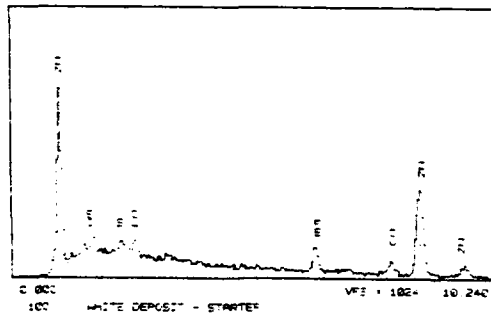
Figure 5.8-1. Field Failure Case History

Exterior Housing View

Brush Assembly View

WHITE DEPOSIT - STARTER

Starter Motor in Water

Develop special maintenance procedures to be utilized after deep water fording in brackish or salt water environments.

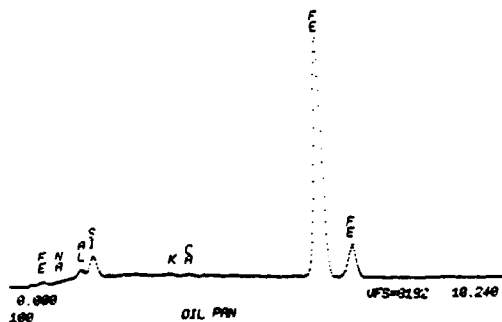
Figure 5.8-2. TRC Failed Component Case History

- Extensive failure of external paint protection
- Heavy general corrosion attack to the point of penetration
- Minor general surface corrosion of inside surfaces.  
(After the part was cleaned and degreased)
- Wall was penetrated in deepest part of oil well resulting in loss of engine oil

Interior View

Inspection of two year old field vehicles demonstrated early signs of paint chips, spalling and areas of general corrosion attack. Continued inspection and maintenance of oil pan external surfaces will extend life. This part may fail premature of TRC projections.

Exterior View

Section Adjacent to Penetration Showing Corrosion of Exterior Surface

Penetration in Oil Pan

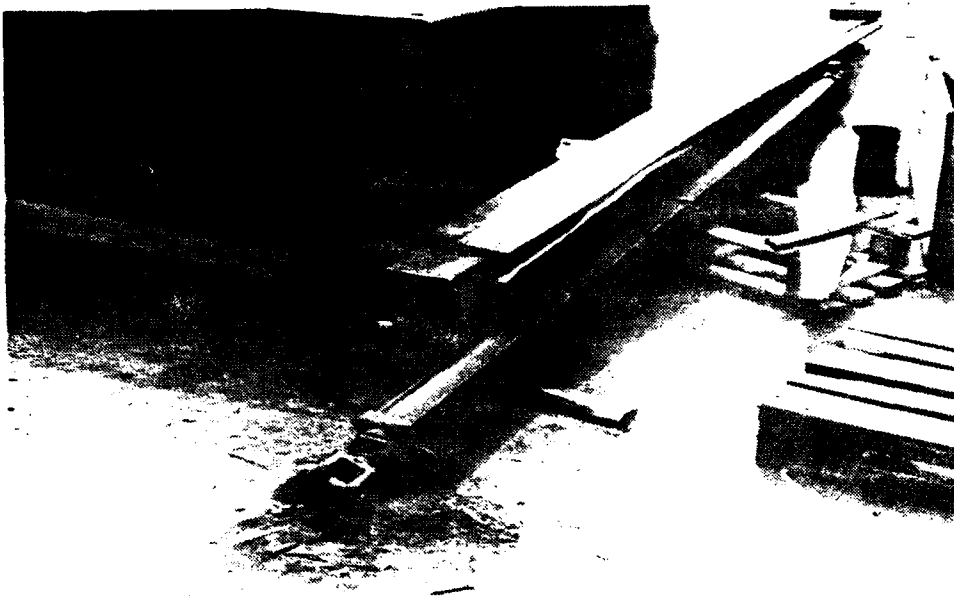
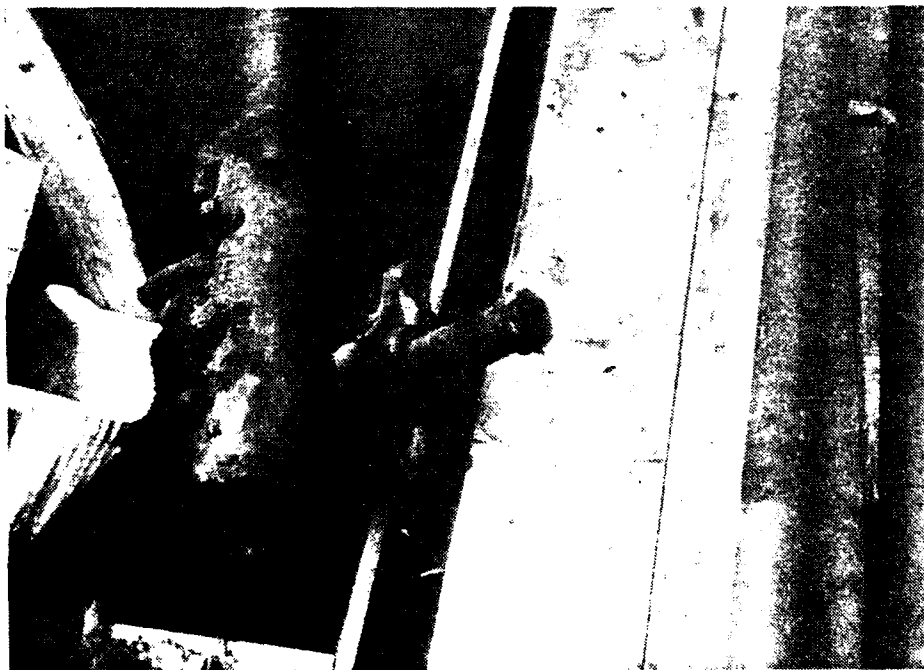
Figure 5.9-4. Damage to Containers and Corrosion of Exposed Components

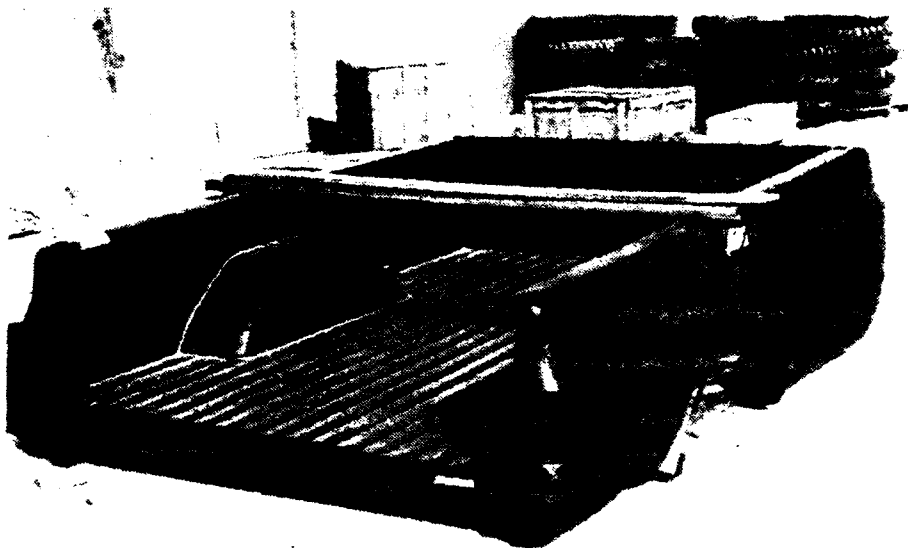
Figure 5.9-5. Outside Storage of Body Components

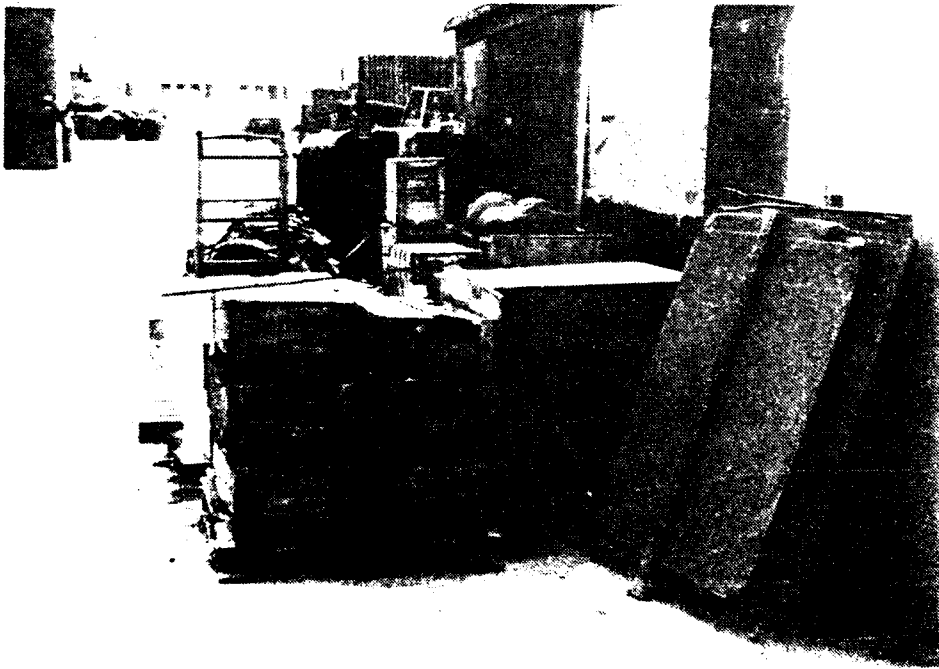
Figure 5.9-6. Outside Storage of Cardboard Containers and Wood Crates

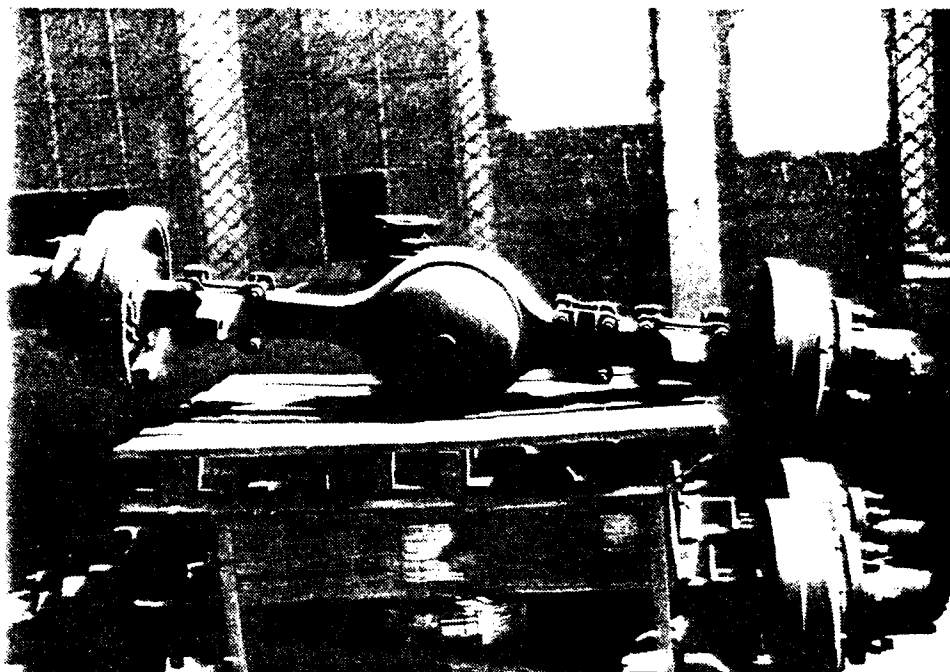
Figure 5.9-7. Outside Storage of Large Components

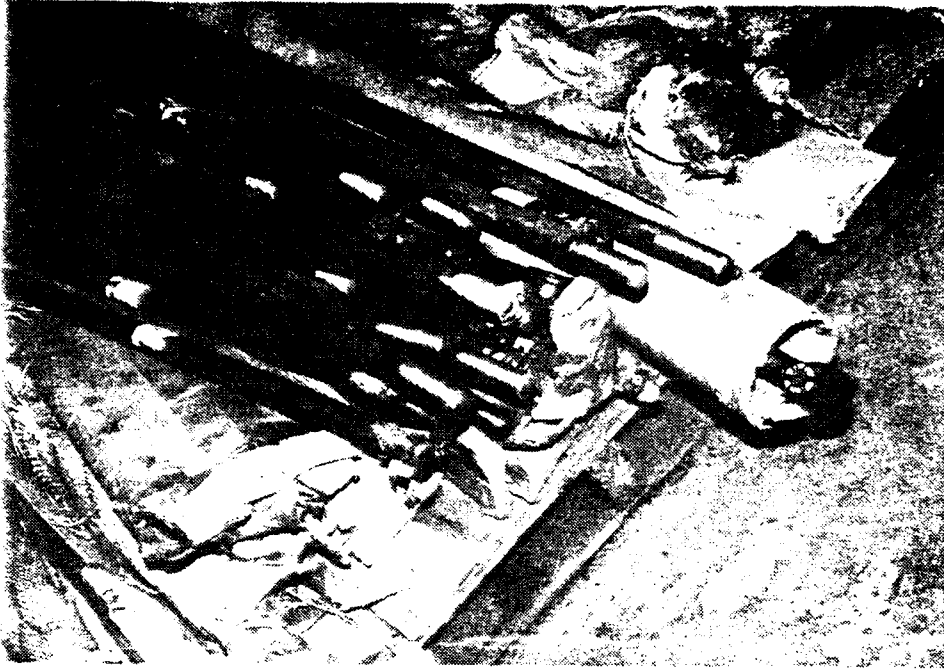
The parts which have been removed from the package are then stored by stacking them on large racks and shelves without intermediate packing material, resulting in metal-to-metal contact. Such storage results in abrasion or spalling of protective coatings, such as paint or film lubricants, exposing underlying base metal to general atmospheric erosion. Examples of corrosion problems associated with indoor storage of large parts that have been removed from O.E.M. packaging are shown in Figures: 5.9-8 and 5.9-9.

Figure 5.9-8. Indoor Storage of Large Components

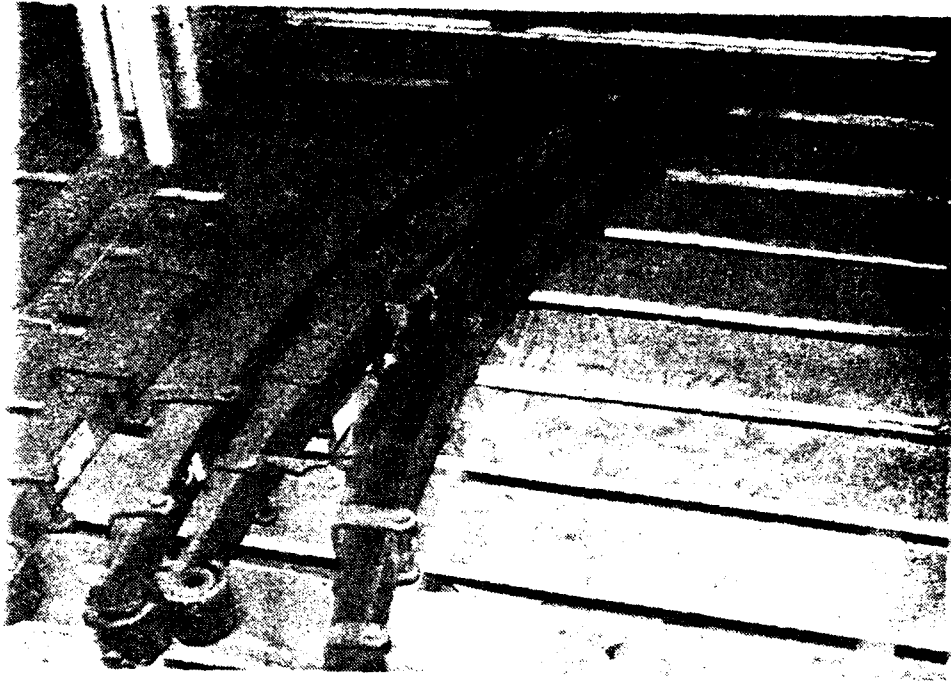
Figure 5.9-9. Indoor Storage of Large Components

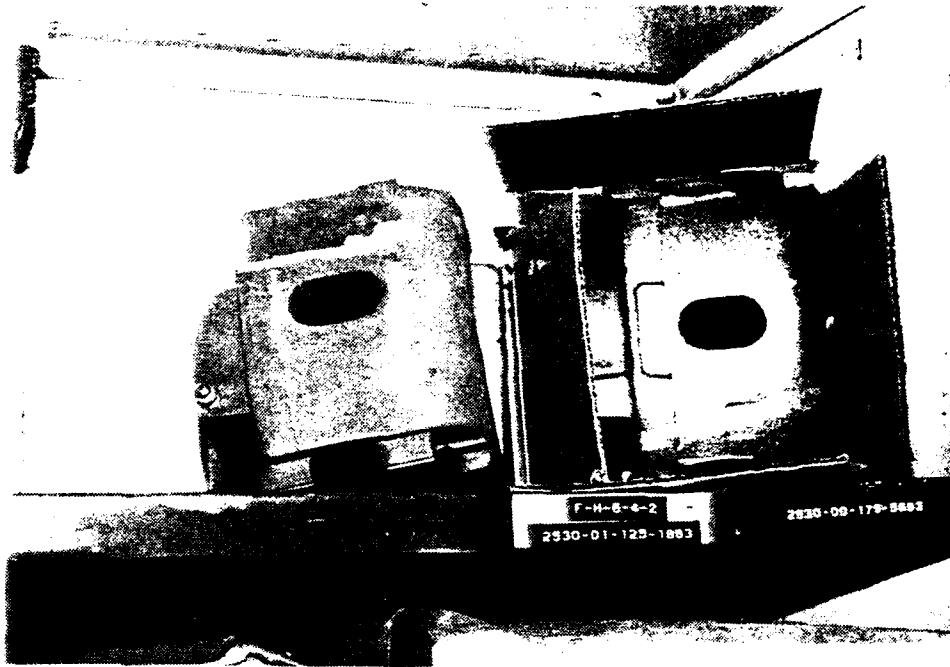
Figure 5.9-12. Parts Returned From Lower Level Maintenance Organizations O.E.M. Packaging Has Been Discarded

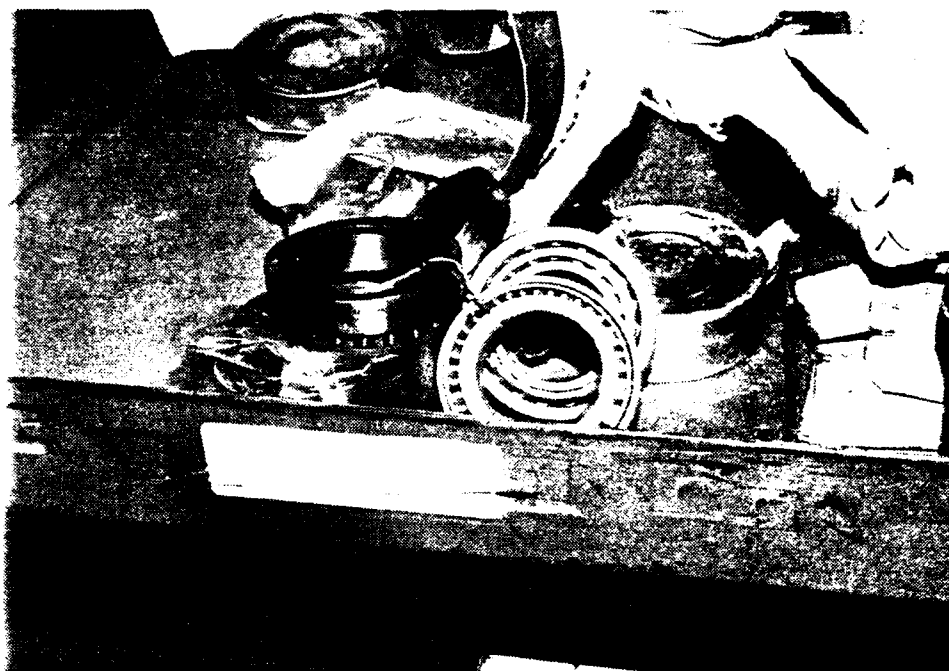
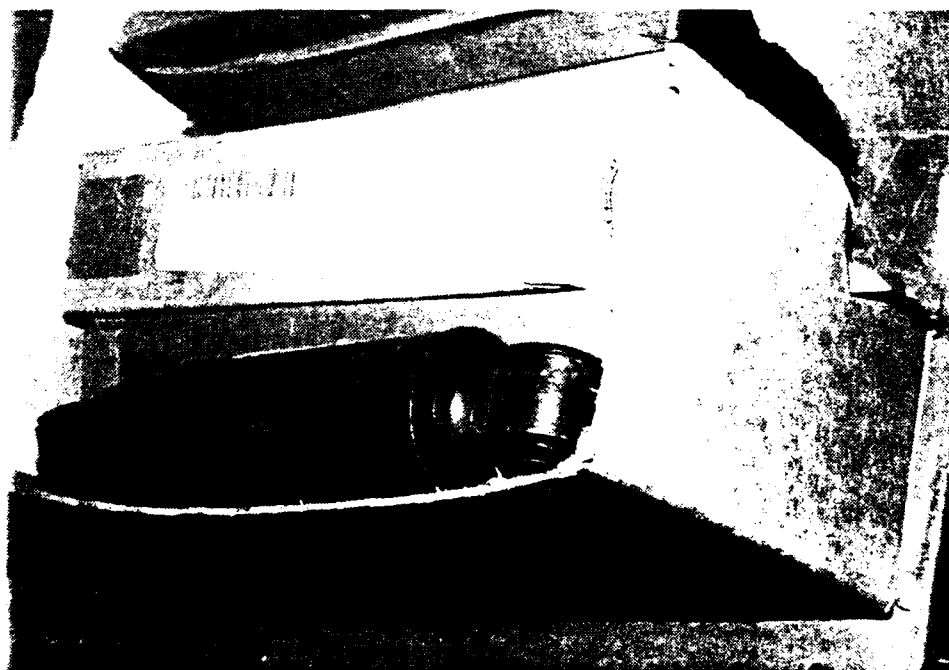
Figure 5.9-13. Parts Returned From Lower Level Maintenance Organizations O.E.M. Packaging Has Been Discarded

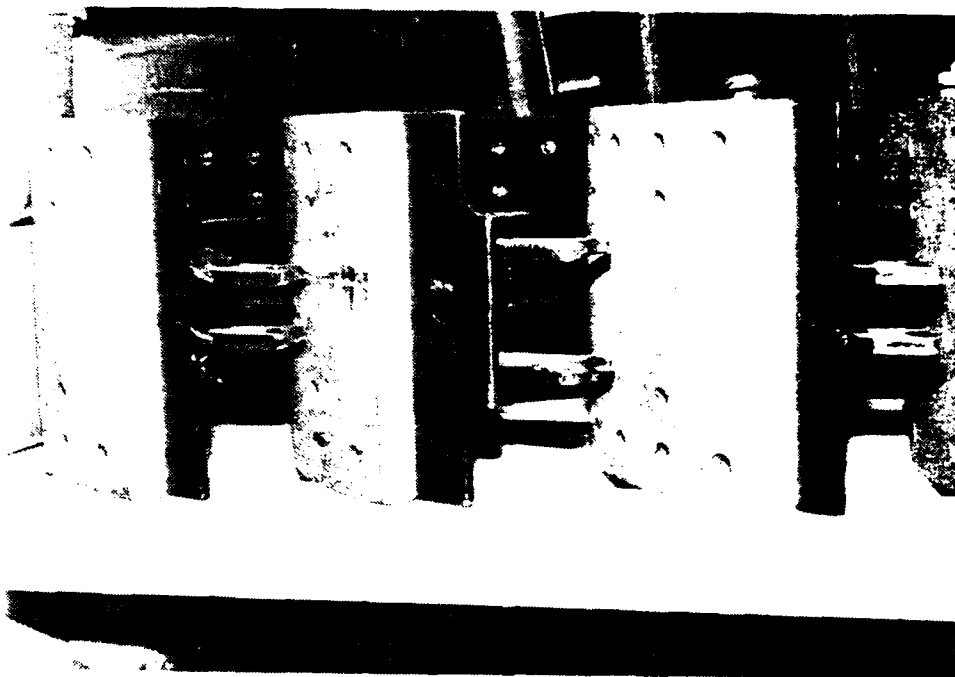
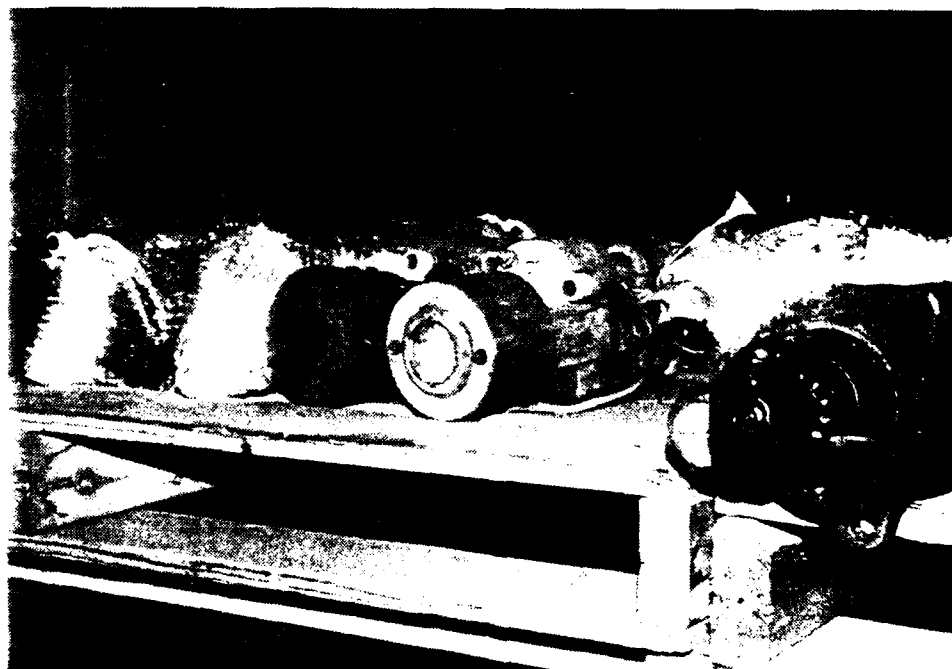
without addressing an associated corrosion problem. Examples of repaired, reconditioned, or used-part inventory storage, without protective packaging, are shown in Figures: 5.9-14 and 5.9-15.

Figure 5.9-14. Remanufactured / Used Parts Without Packaging

- Increase indoor storage area. Although square footage is often a problem, improvement in organization of parts inventories can be substantially improved. Make better use of vertical space. Parts spread out on the floor or on pallets consume greater quantities of square footage by comparison to those storage areas that make use of vertical racks, shelves, etc. Organization of this nature will also reduce packaging damage, minimize handling, and save time searching for inventory items.

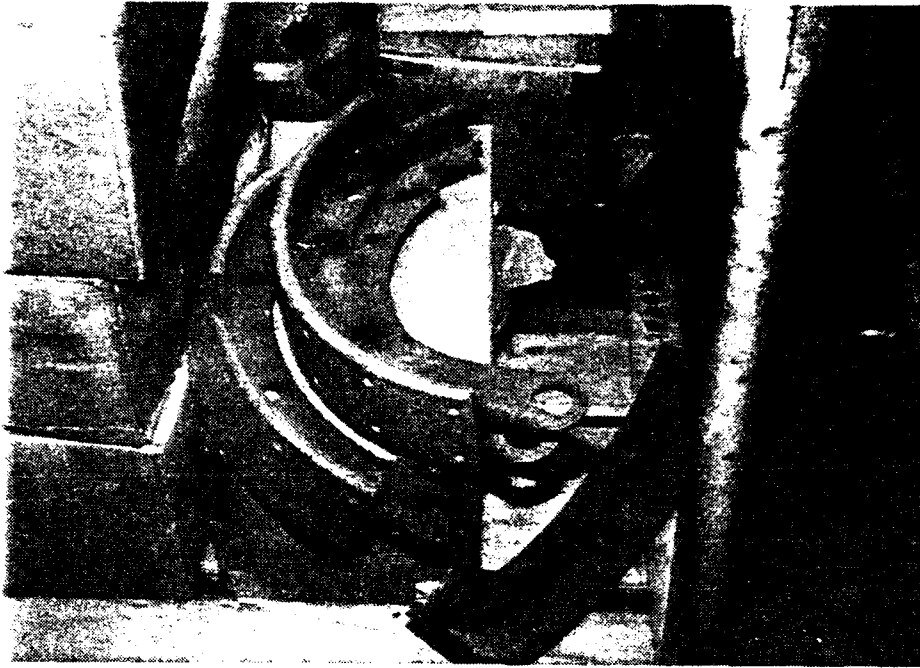
Figure 5.9-15. Rebuilt / Used Parts Without Packaging

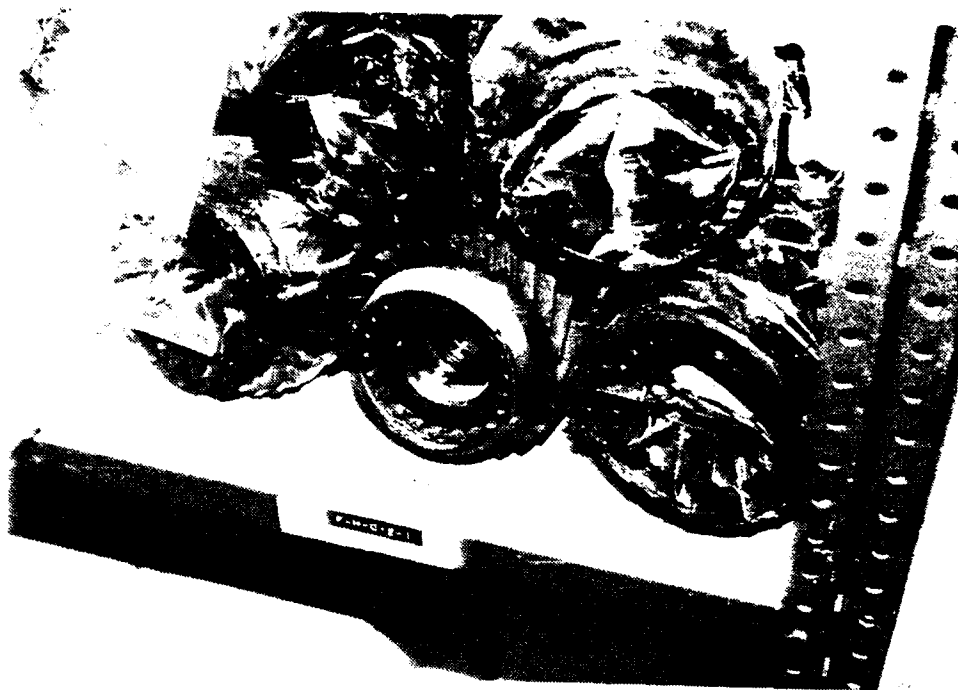
Examples of inadequate O.E.M. packaging and physical damage to packaging are shown in Figures 5.9-16 and 5.9-17.

Figure 5.9-16. Inadequate and/or Packaging Damage

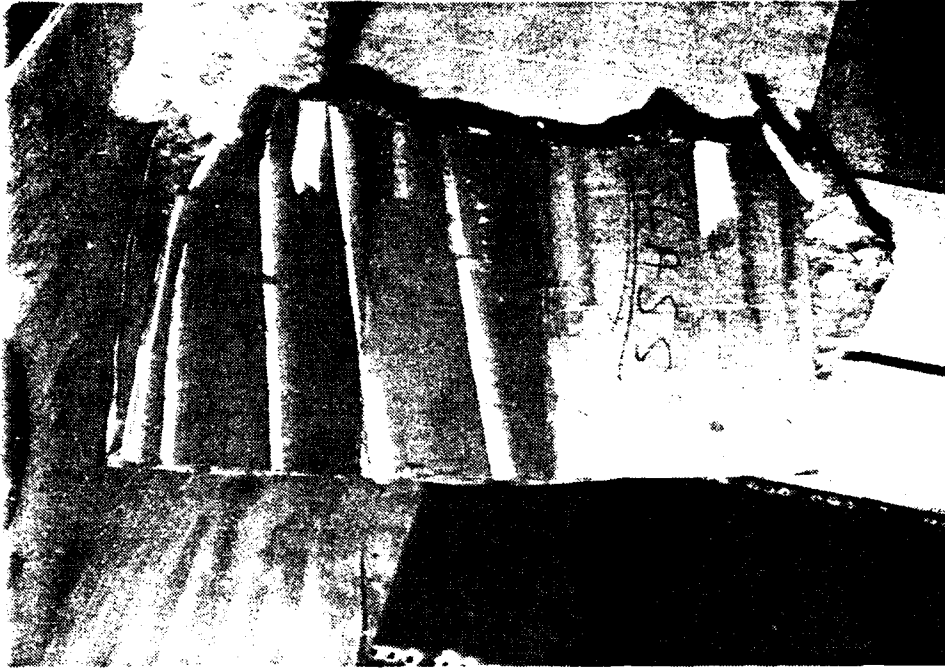
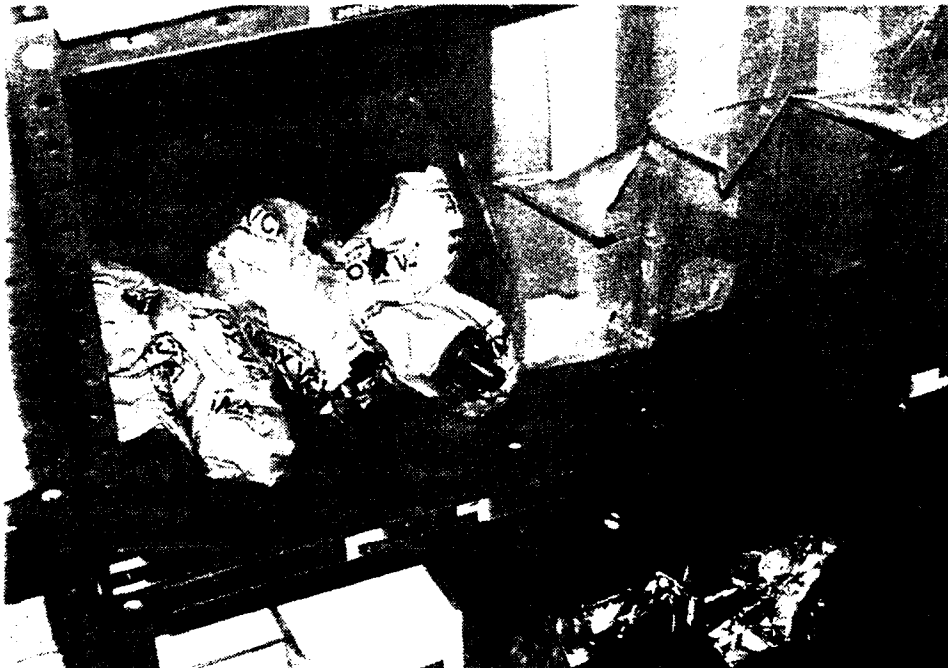
Figure 5.9-17. Inadequate and/or Packaging Damage
